RE: RP002640000100

Moving the building envelope on this site or any other site within the Daydream Ranch Subdivision will not require test holes. Recent test holes dug across the subdivision have shown **NO** evidence of groundwater above 10 feet (120 inches). The location of a residential structure has no bearing on the type or depth of a septic system. There is no need for further soil evaluation on any lot within this subdivision. Minor plat changes such as building envelopes is up to the HOA and the Planning and Zoning Department of Teton County. A change of this sort has no bearing on the State of Idaho subsurface wastewater disposal systems as regulated under IDAPA 58.01.03 legislated rules.

Daydream Ranch Subdivision

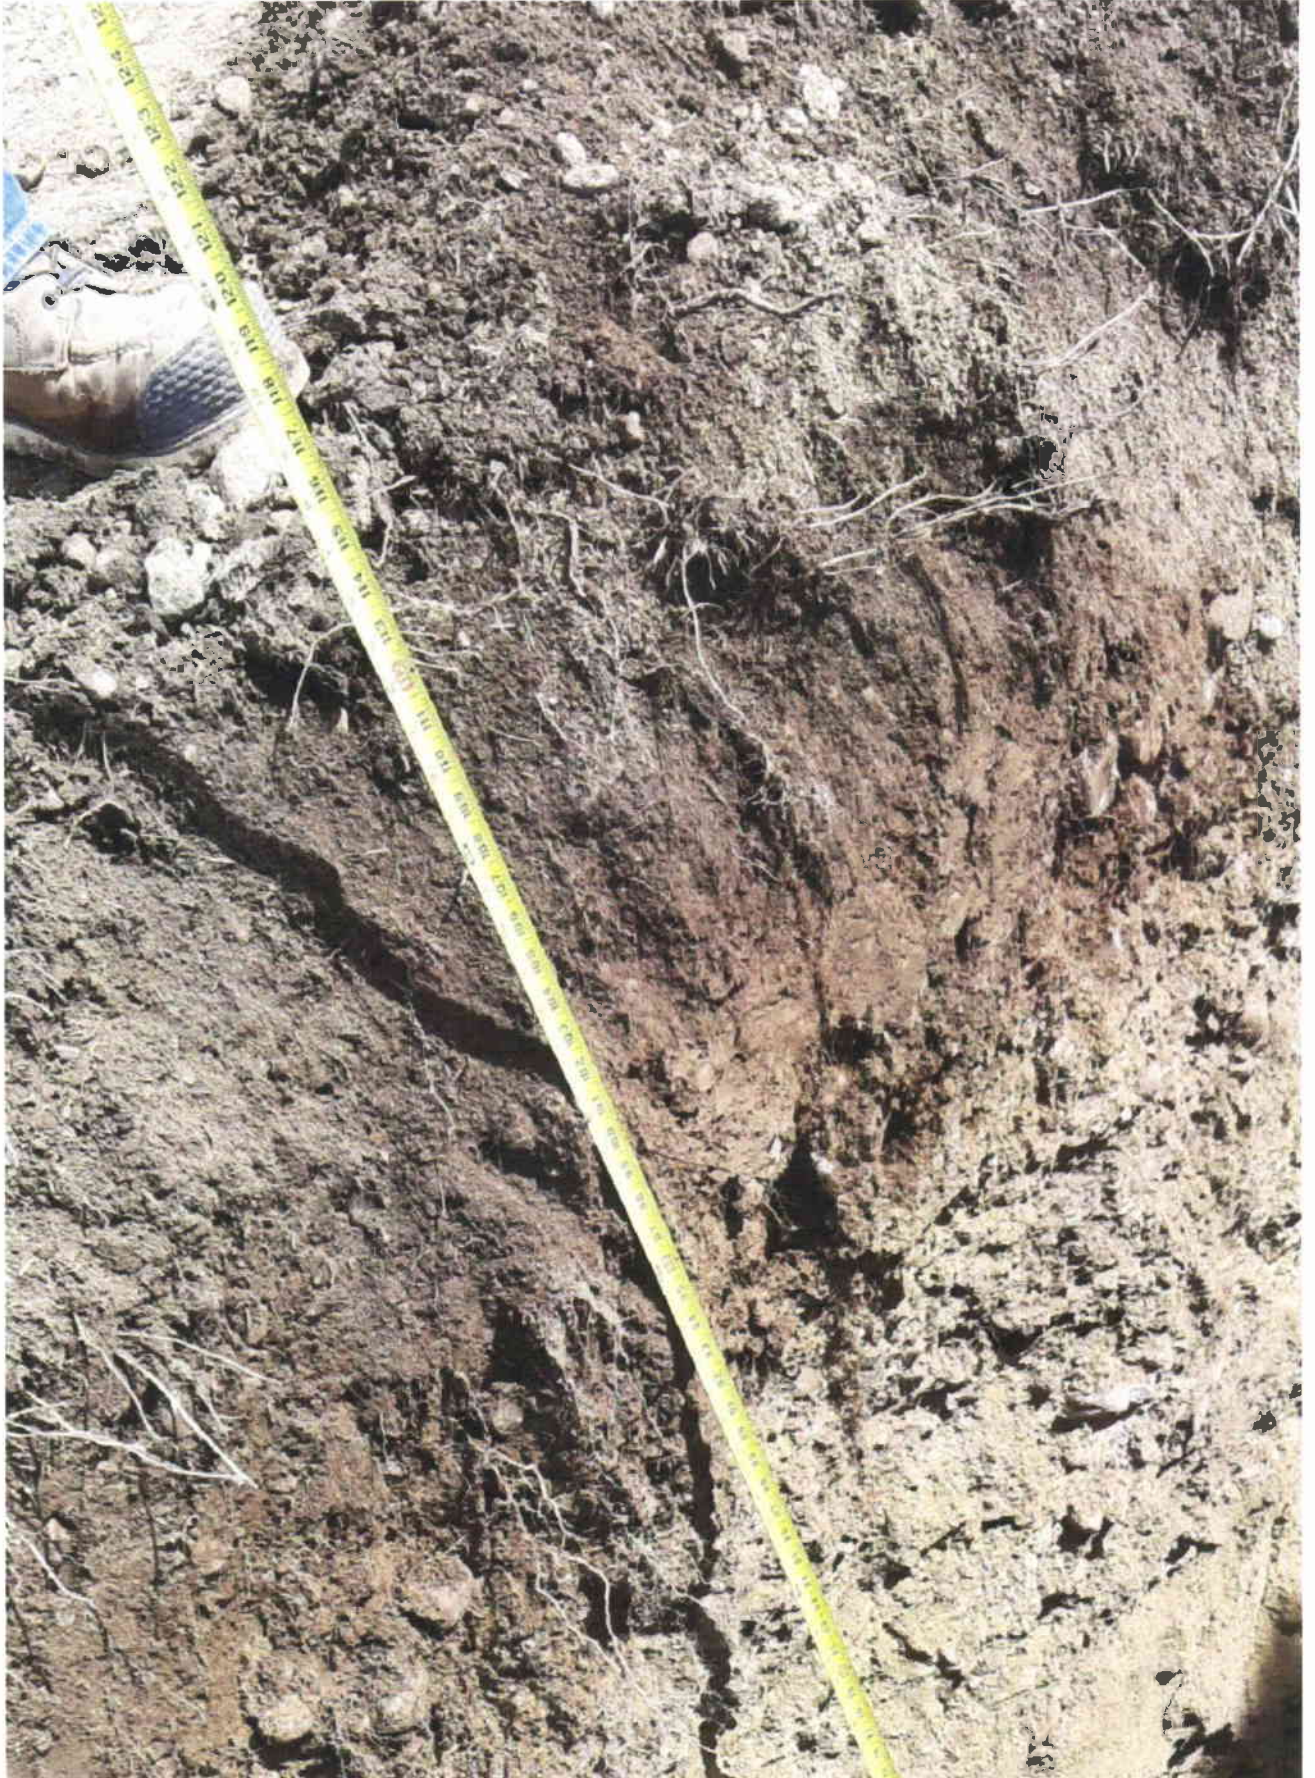
Ground Pit
Ground water levels below 144' during Spring + Fall

Lot 10 - No Surface water

Slope $< 3\%$

No evidence of GUD
through out subdivisions
@ this time.

Recent T.H.
on lot 12:
4/7/2024
Silty loam / Minor
rock content
gravelly sandy loam
medium sand
minor fines
25% rock content
114"
120"
No Groundwater
No Bedrock.
