04/23/2024

RE: Daydream Ranch Subdivision

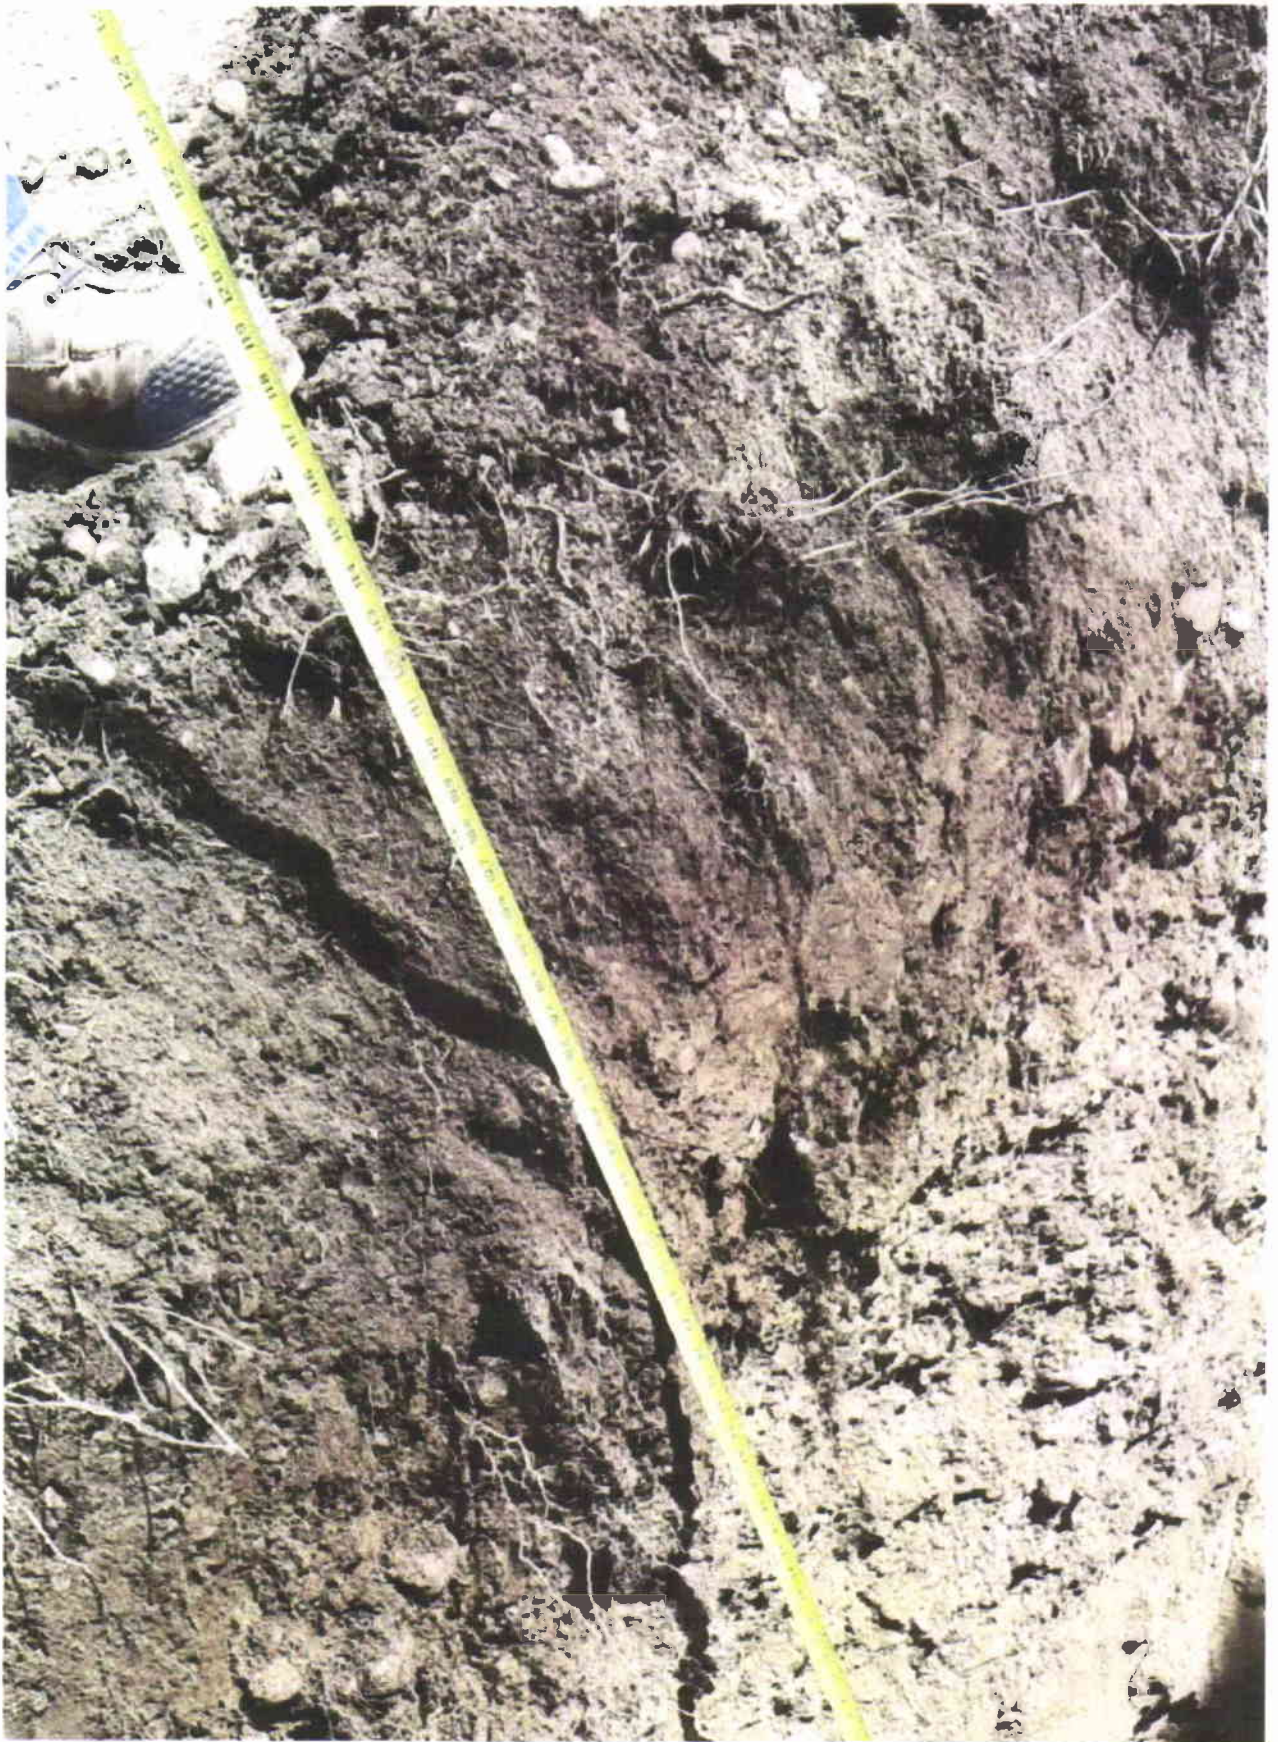
0-18 inches of silty loam with minor rock content (Topsoil)

18-114 inches gravely sandy loam. Medium sand. Minor fines. 25% well rounded pebbles up to 3-inch diameter. B1 Soil type.

No bedrock was encountered. There was no evidence of groundwater to depth. No accumulation of water. No mottling of the soil. No weeping of groundwater at any depth to 114 inches (9.5 feet).
