# FRAIZ RESIDENCE

## COMPENSATORY MITIGATION PLAN

Intermountain Aquatics, Inc.  
116 Mustang Dr.  
Driggs, ID 83422

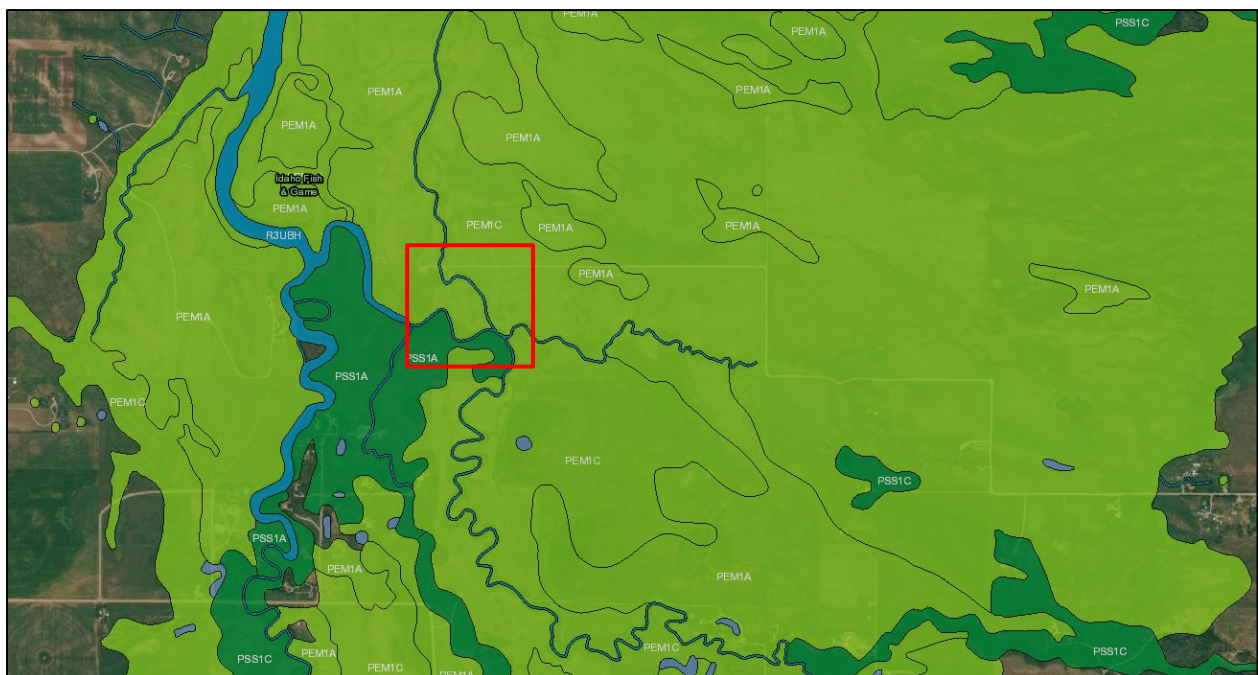
**Figure 2. National Wetlands Inventory map for Project vicinity. Fraiz Property (red) is within the Foster Slough wetland complex. Coarse-scale NWI polygons contain unmapped upland inclusions.**

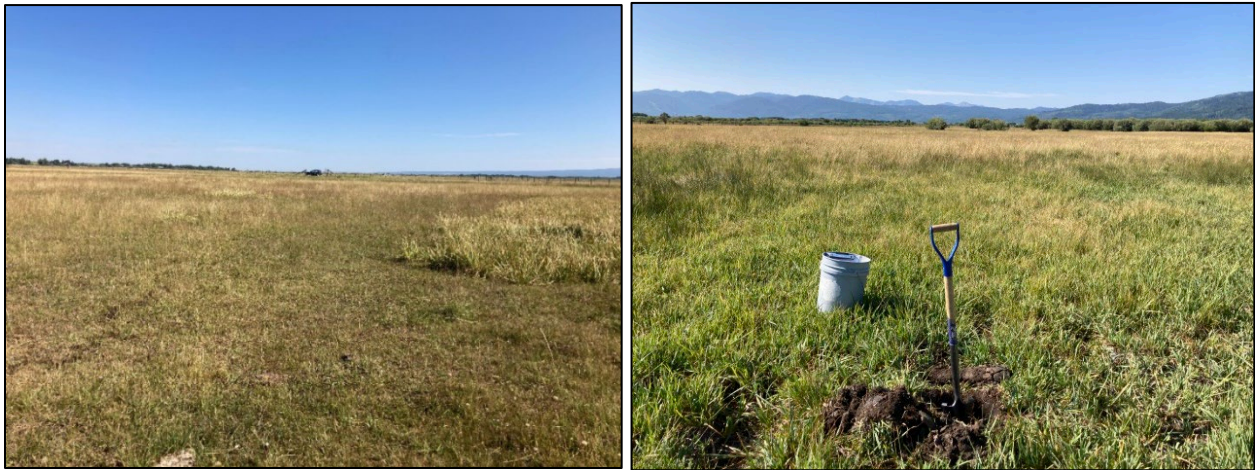
**Figure 6. Impact site at drier (left) and wetter (right) areas.**

The impact site is 0.5 acres of palustrine emergent wetland dominated by native grasses/graminoids with some non-native grasses and noxious weeds (Figure 6). Development is restricted to the northeast corner of the Property by the TRLT conservation easement. This corner of the Property is on higher ground outside of the 100-year floodplain (draft 2022 FEMA FIRM). The ground surface is 1-4 feet higher than the wetlands and streams that occupy most of the site. Existing wetland hydrology here depends partly on irrigation return flow from a ditch that ends just east of the Property's northeast edge (visible on Figure 4). The 1998 TRLT baseline report, historic aerial imagery, and onsite observations show that the impact site is crossed by a longstanding farm access road and has been heavily used by livestock grazing and traveling to a feeding area in the upland next to road W 5000 S.

This site has relatively low functional value compared with the rest of the Property due to its higher elevation, isolation from streams, limited hydrology, historic grazing impacts, and lack of vegetation structure. Like the rest of the northern edge of the property, it is next to a well-used county road. Impacts due to fill for buildings, a driveway, utilities, and landscaping will be permanent and will include minor losses of low-quality habitat, off-stream runoff storage, and pollutant removal. No direct impacts to streams or other open water will occur.

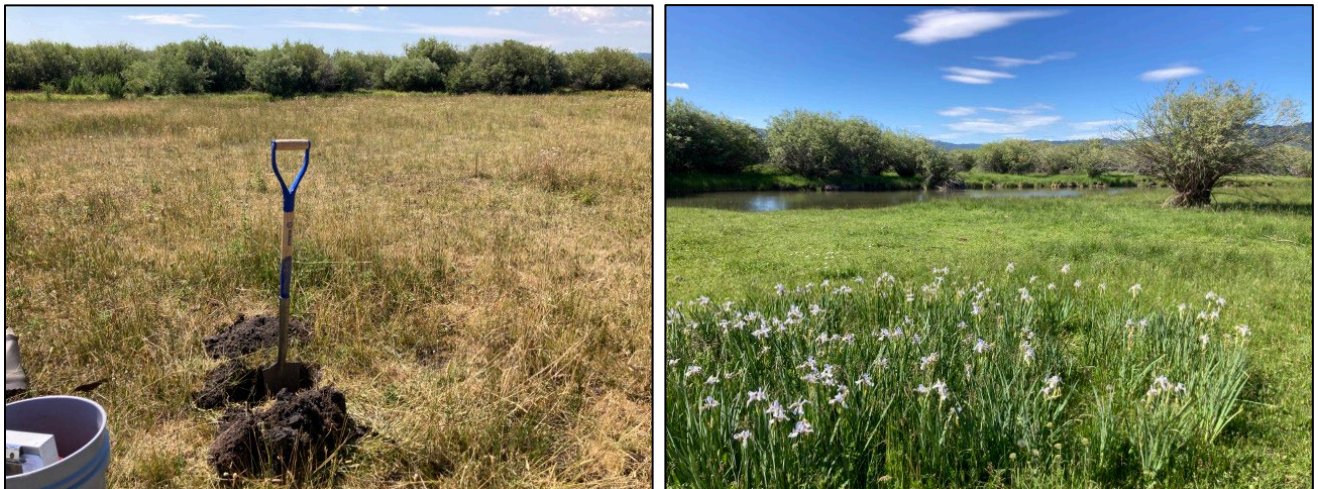
**Figure 7. Mitigation site at drier upland area (left) and facing south from upland towards Fox Creek with PEM/patchy willows on adjacent lower ground and PSS wetland on opposite bank (right).**

The proposed mitigation site is an upland “island” north of Fox Creek and west of Foster Slough (Figures 4 and 7). It is dominated by FAC herbaceous species with smaller cover of FACU, FACW, and UPL species. Plants include native and introduced grasses, graminoids, and forbs. The site has been degraded by grazing. Canada thistle and musk thistle are common. There are no shrubs or trees.

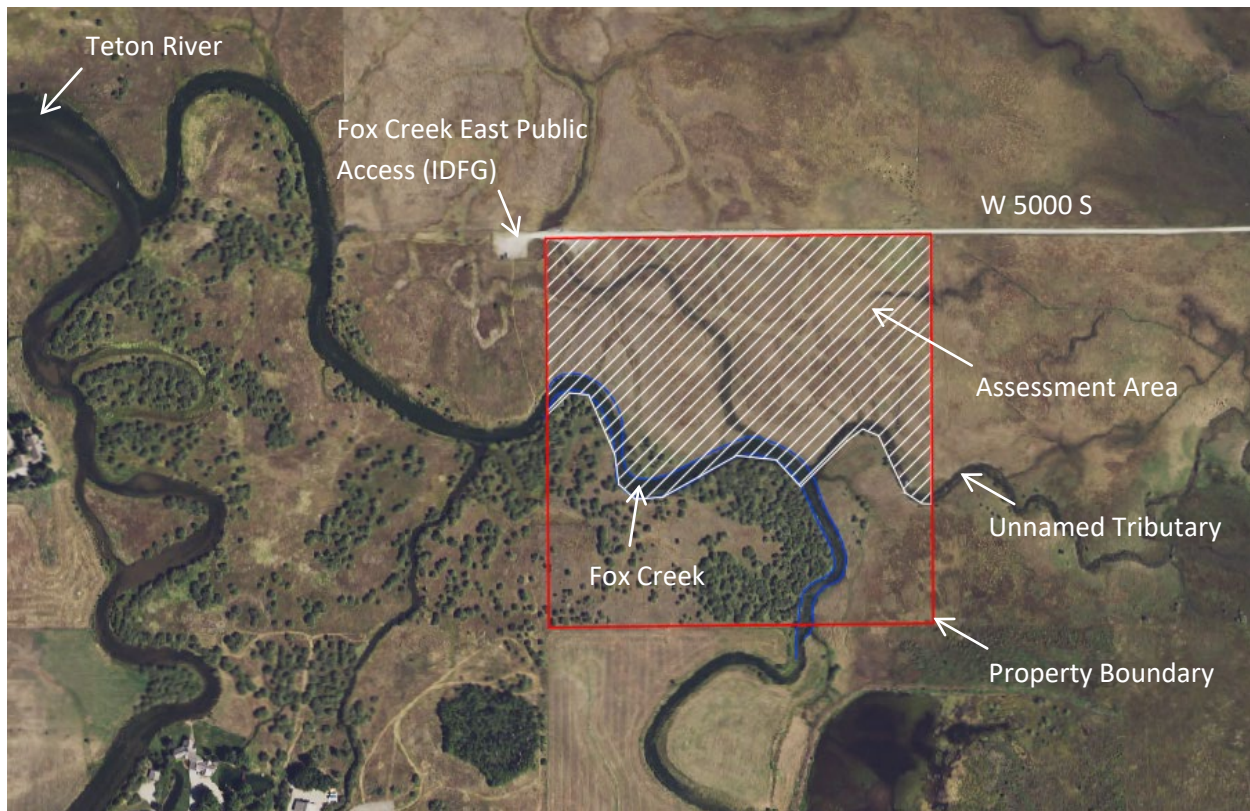
**Assessment Area size:** 17.3 acres PEM excluding upland islands within the 23 acres hatched below

**Figure B-1. Project Property with Assessment Area (AA) hatched in white.**
