Natural Resources Analysis and Aquatic Resource Inventory

Skyline View Ranch

20 June 2023

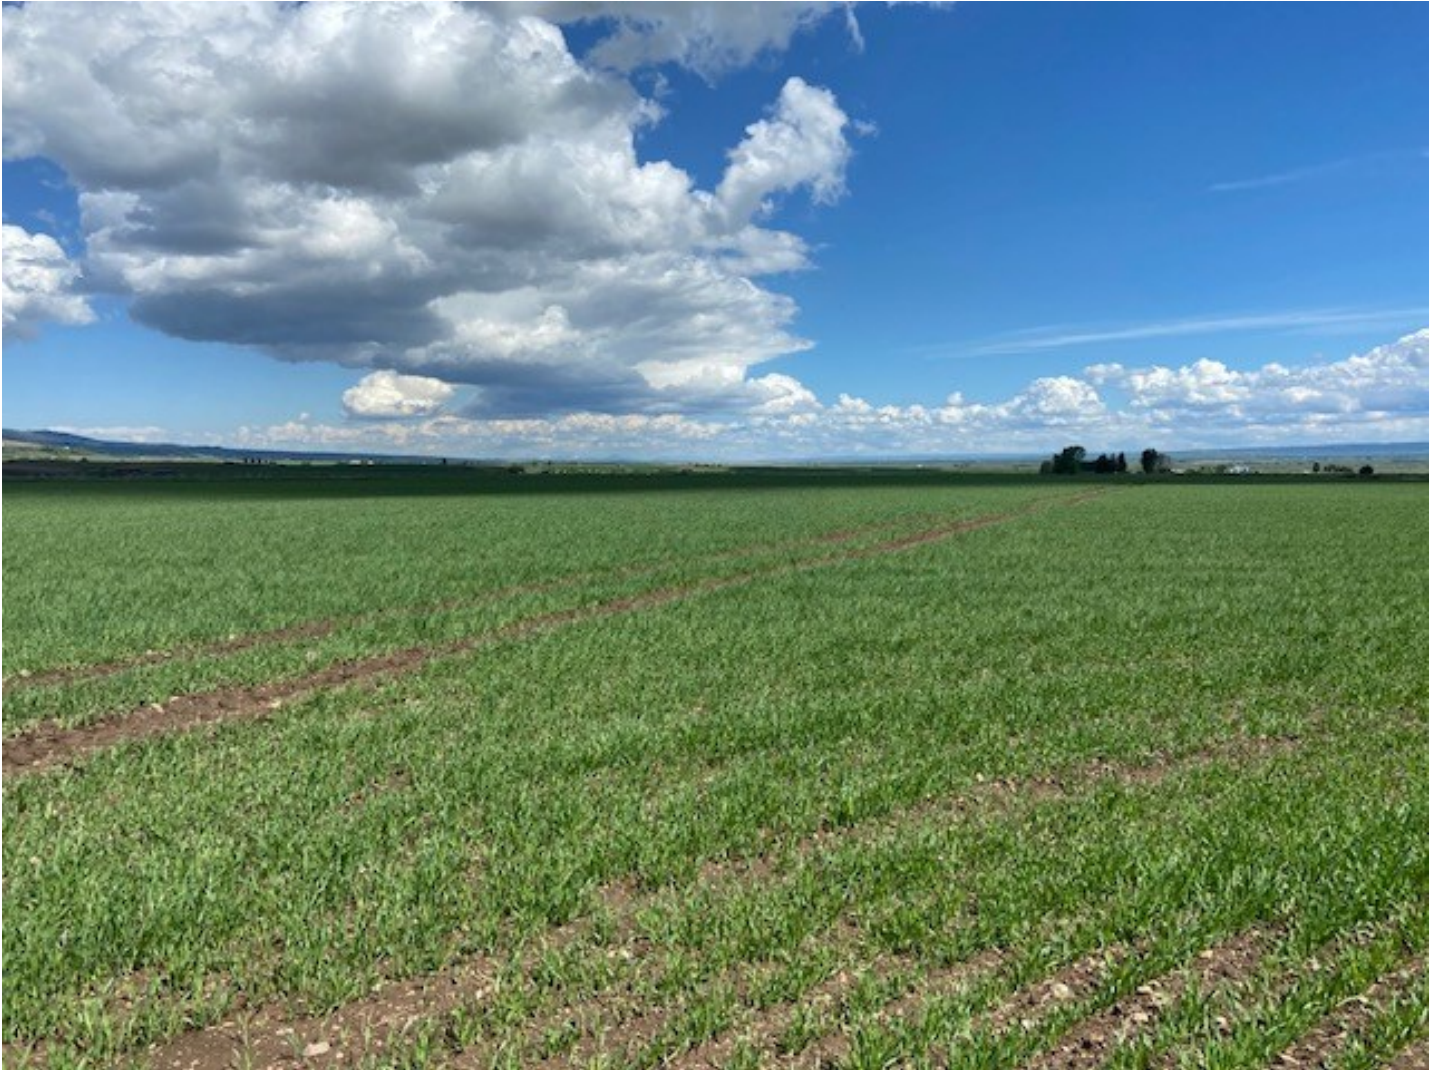
Site Photograph_ Cultivated Cropland—Barley

The parcel is primarily cultivated cropland planted and harvested in barley (Appendix-Aerial Photograph 2021). Farming operations within the parcel are currently ongoing.

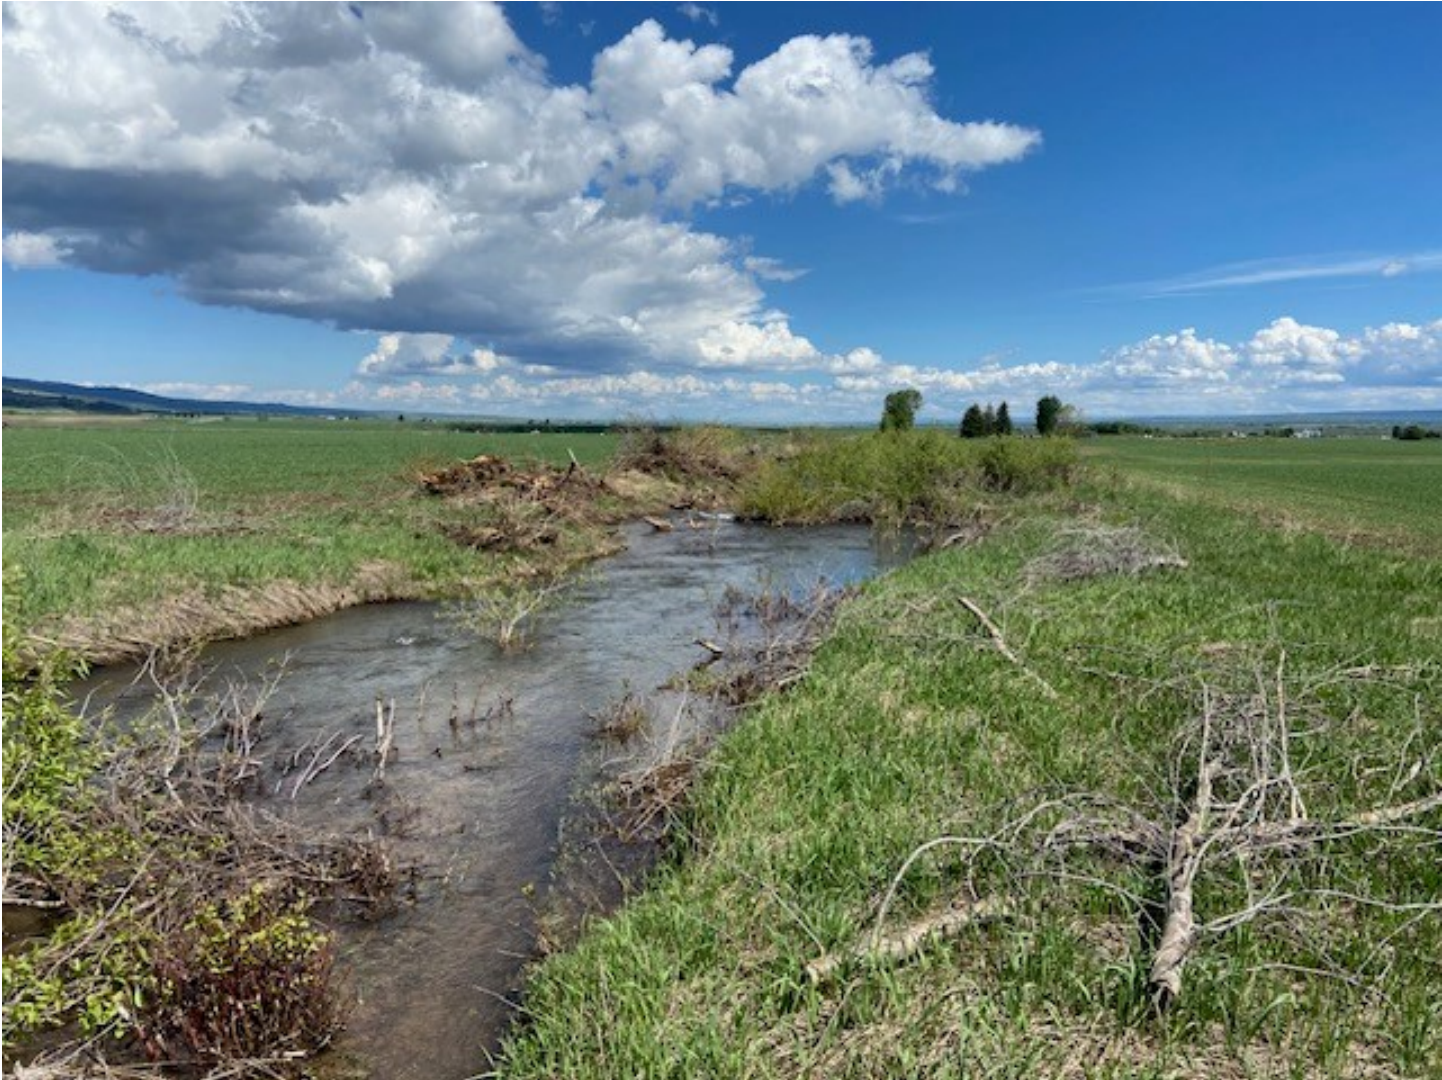
Site Photograph_ View of Mahogany Creek near Center of Parcel

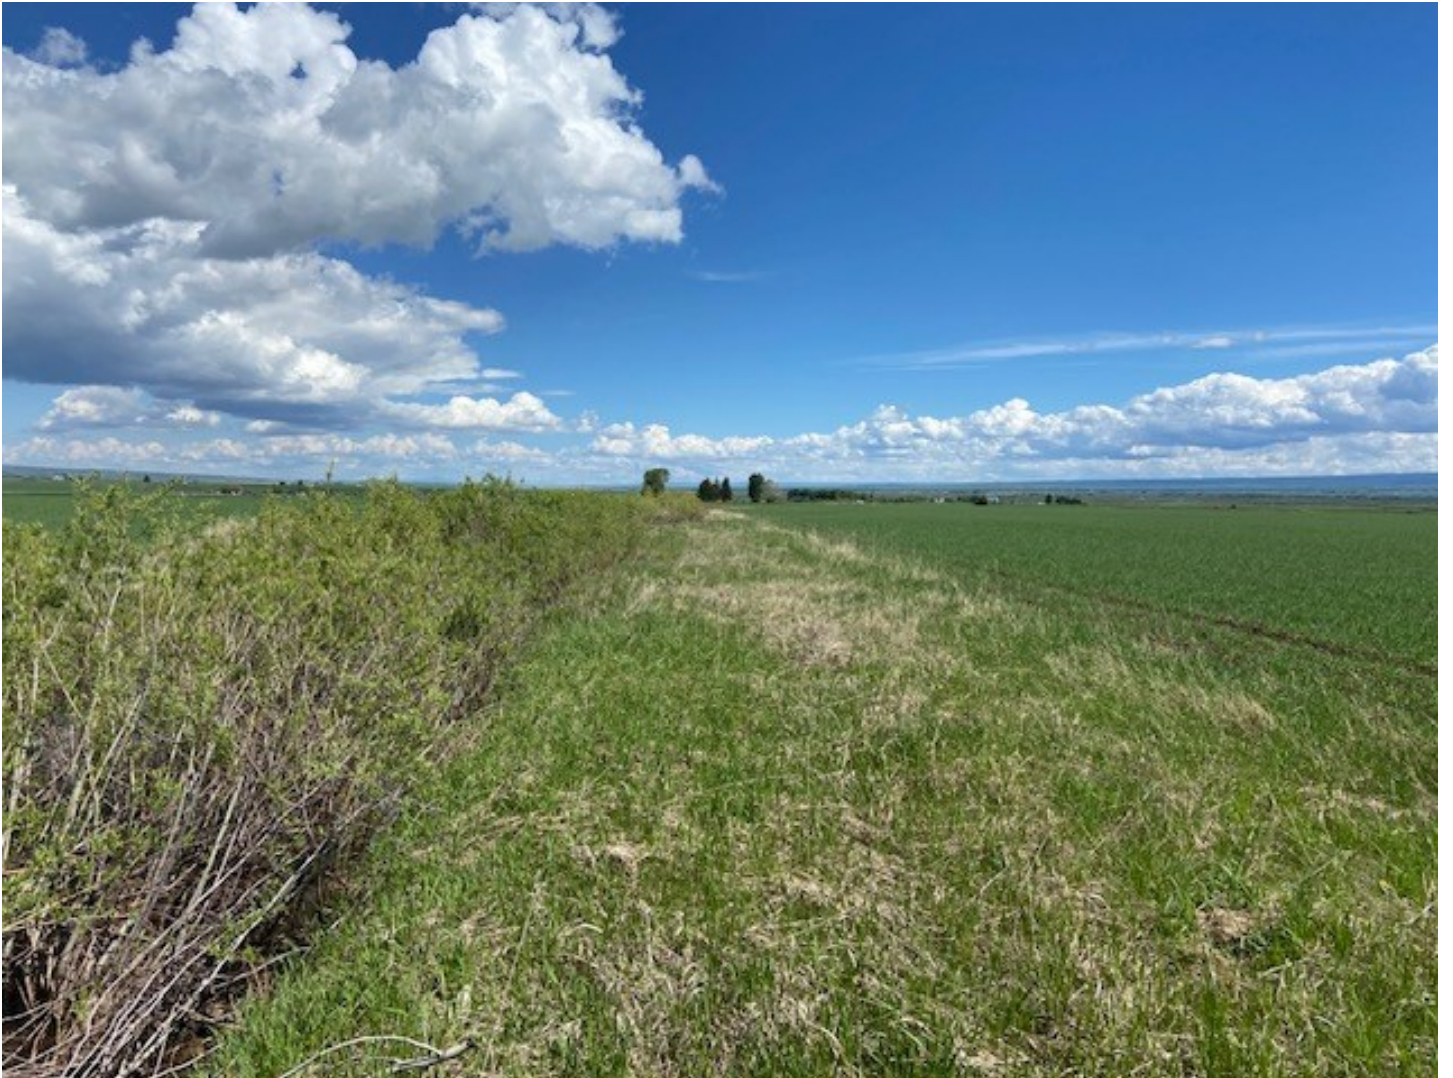
Site Photograph_ View of Mahogany Creek
