## **Natural Resources Analysis and Aquatic Resource Inventory**

### **Skyline View Ranch**

**20 June 2023**

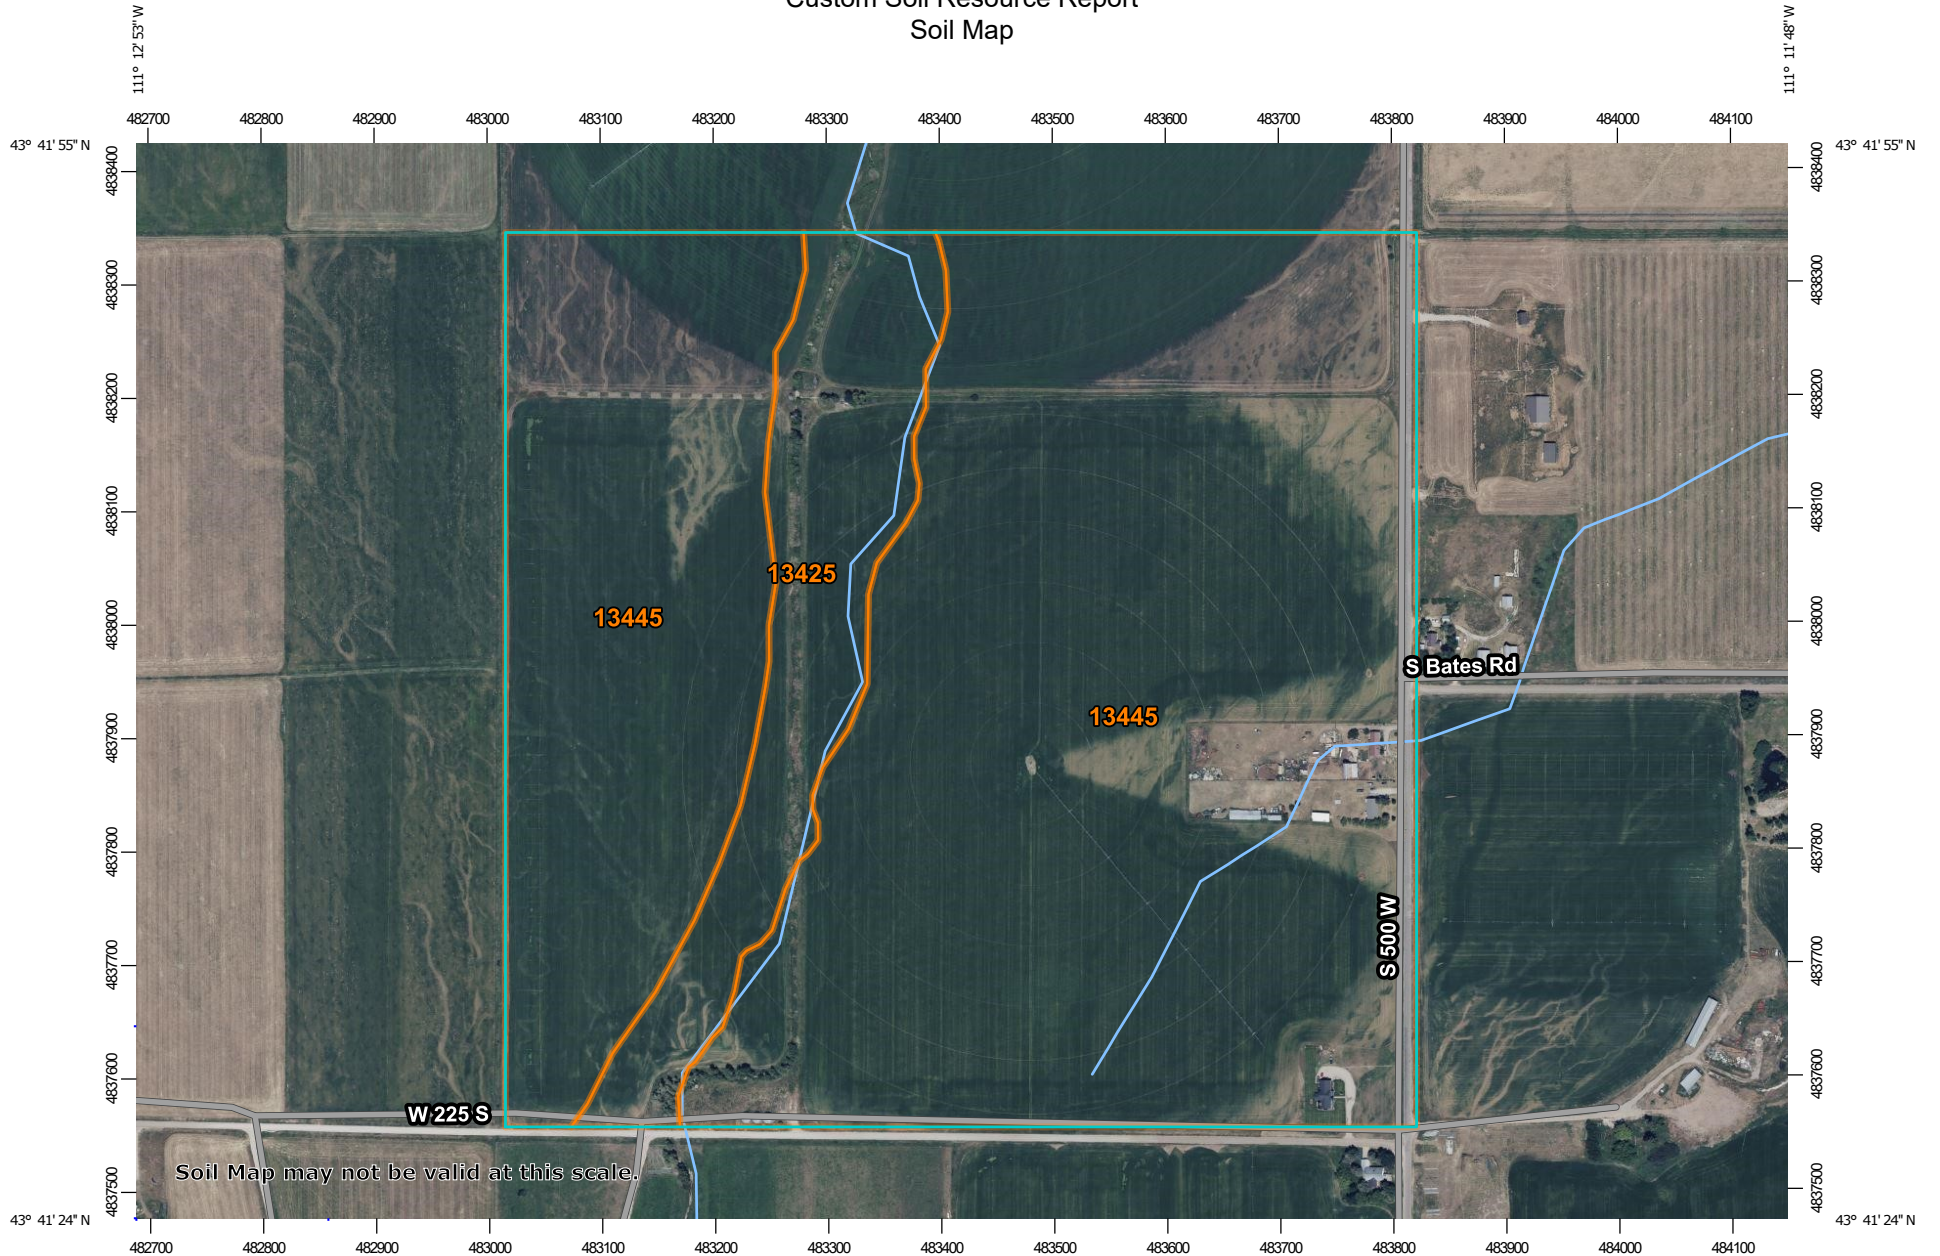
# Custom Soil Resource Report Soil Map

The Natural Resources Conservation Service USDA - Soil Map of the site includes the following soils in order of dominance (Appendix\_Soil Map).

13425 Badgerton - Alpine complex, 0 to 2 percent slopes

13435 Richvale Silt Loam, 0 to 4 percent slopes

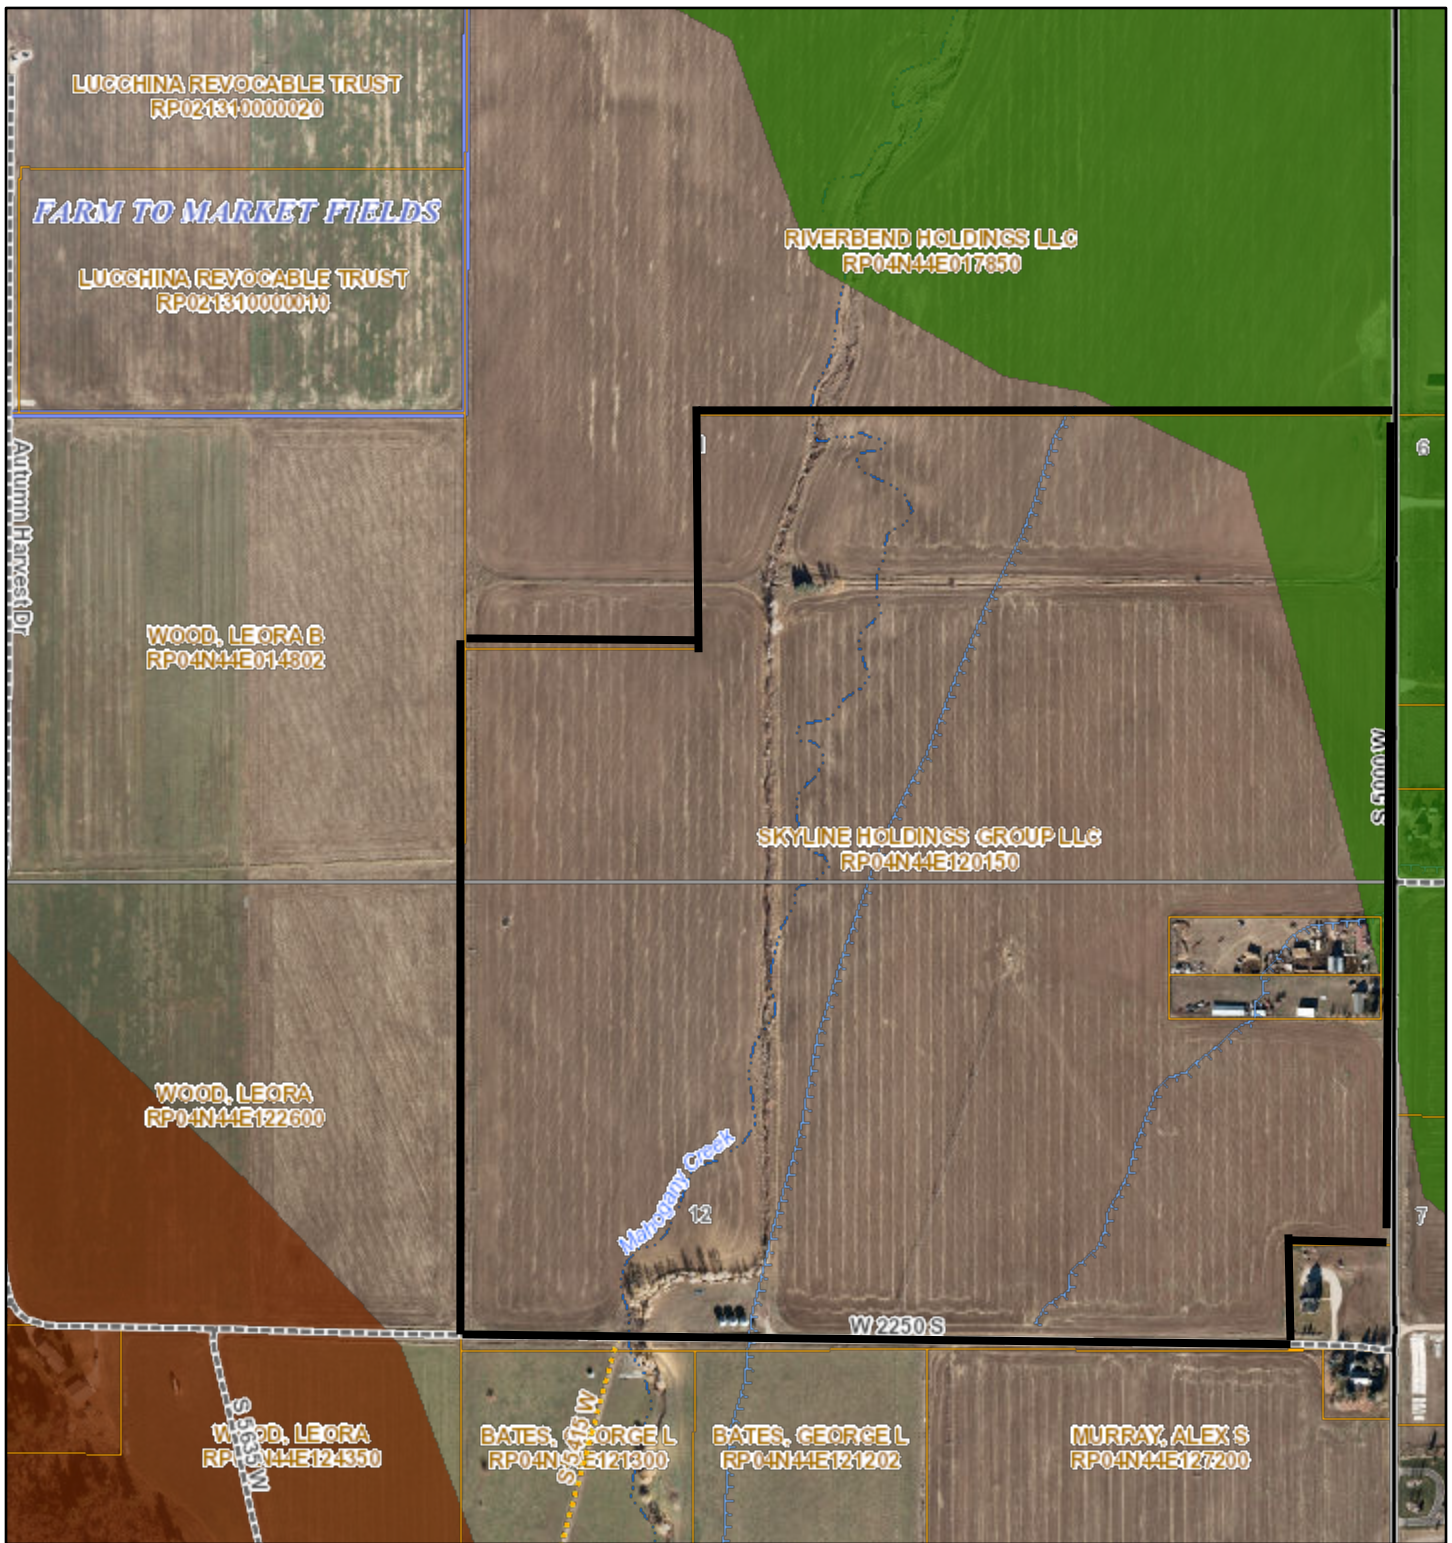
# SkyLine View Ranch Natural Resource Overlay

The Teton County Natural Resources Overlay Map (2006-2022) depicts approximately 9.3 acres of the *Waterbird Breeding, Migration, Foraging and Wintering Habitat*, and approximately 4.4 acres as *Priority Wetland - NWI* within the parcel (Appendix-Natural Resource Overlay Exhibit).

To compensate the loss of foraging habitat for Sandhill Cranes it is suggested that the owner replant the parcel with drought tolerant grasses and forbs species commonly used for The USDA Crop Reserve Program (CRP). These plantings will provide habitat protection two-fold, forage and cover for water bird species and weed control. Typical species for these plantings could include, Wheatgrass, Meadow Brome, Sainfoin, Fleabane, Orchardgrass and Big Bluegrass.

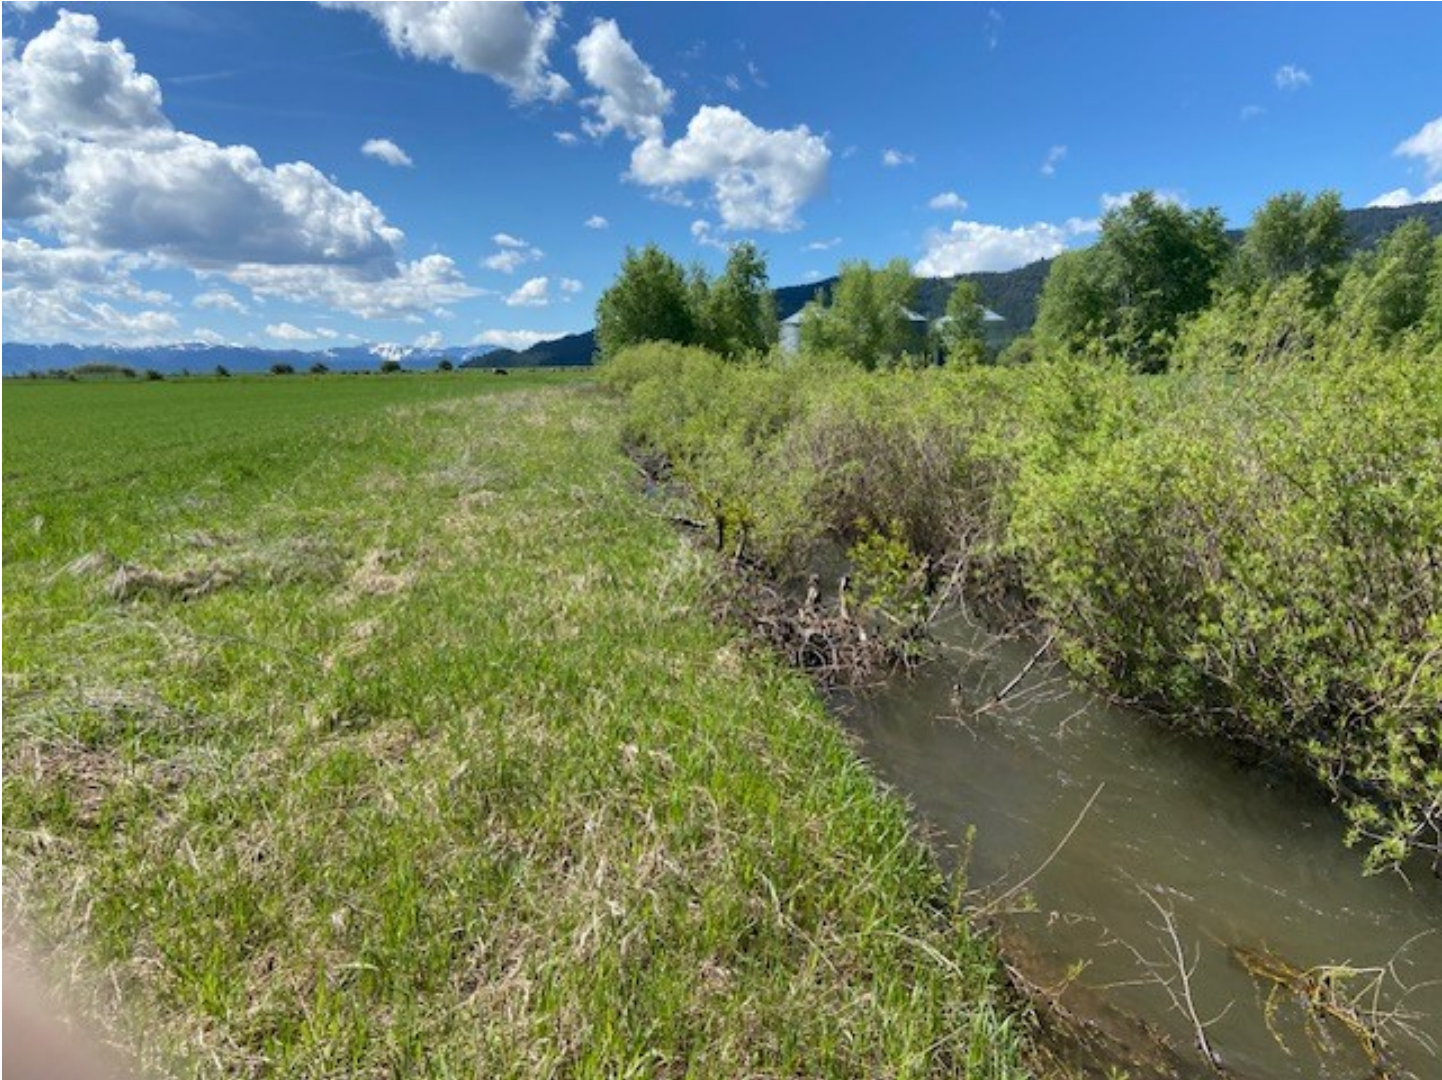
The hydroperiod associated with the Mahogany Creek wetland/riparian area is seasonal and snowpack dependent and varies widely from year to year. There is an existing irrigation pivot (1000') that travels through Mahogany Creek during the growing season.

Site Photograph\_ View of Mahogany Creek looking South at Irrigation Pivot Crossing

As part of the proposed development plan, current farming practices will cease. The center irrigation pivot will be dismantled, and the existing irrigation will be used for a required fire protection pond.

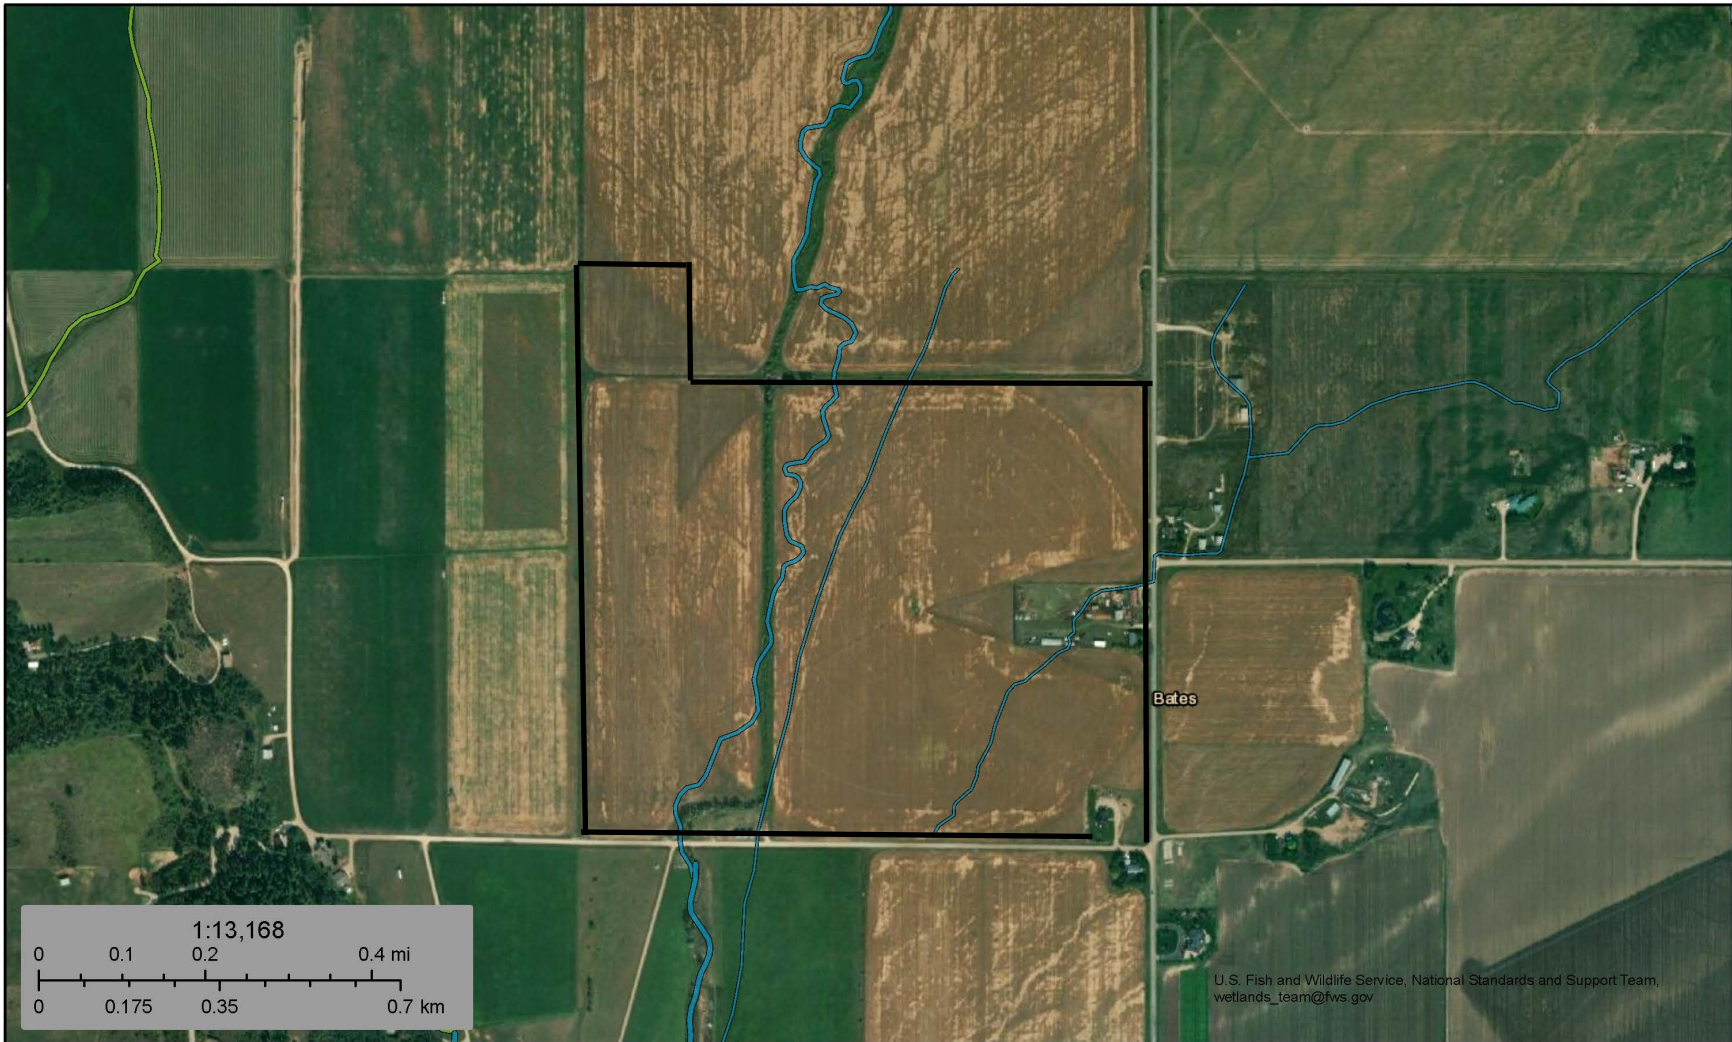
As stated previously the entire parcel minus Mahogany Creek is cultivated cropland planted in Barley. The wetlands associated with the parcel are the seasonal flowing Mahogany Creek which has been channelized through the parcel. The National Wetland Inventory Map classification for this area is riverine (Appendix\_NWI Map).

The NWI map depicts more wetlands than are present within the parcel as determined during the field jurisdictional determination. The creeks depicted on Teton County GIS and NWI Maps are incorrect.

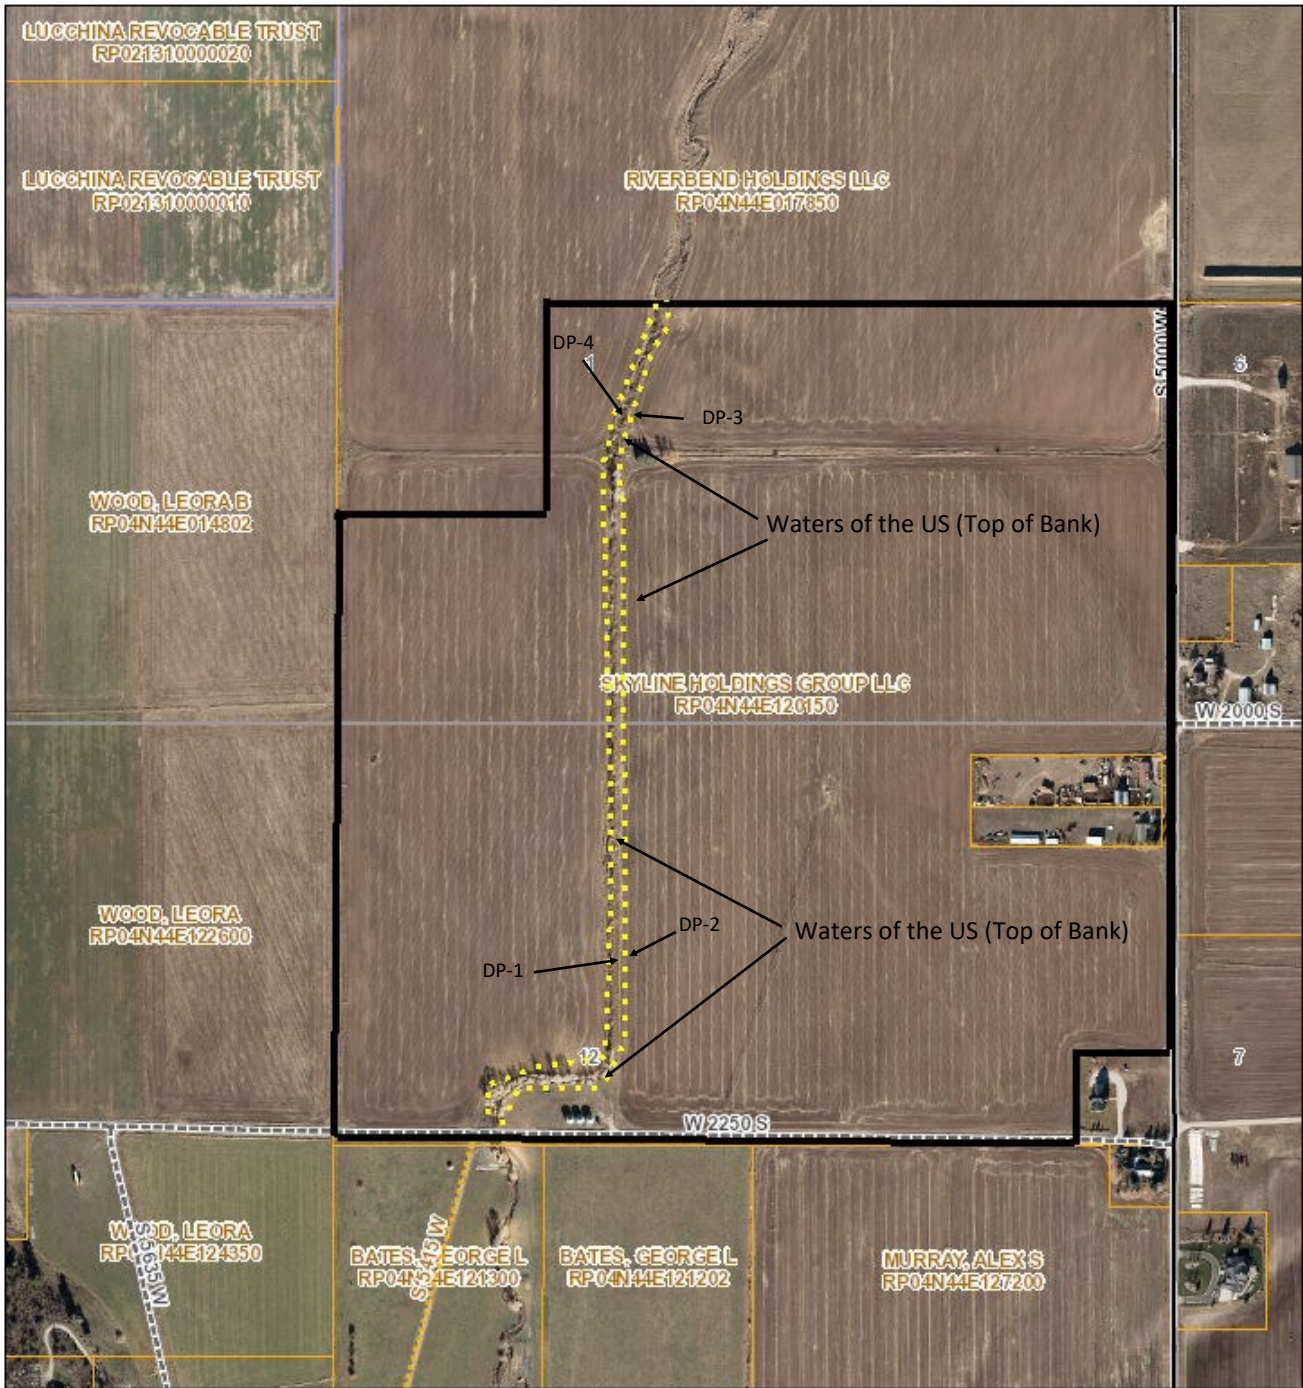
# Skyline View Ranch\_Waters of the US (WOTUS)

As discussed, the creek has been channelized through the parcel and the wetlands are at the top of the bank of the creek. These revised wetland boundaries are shown on the WOTUS Exhibit (Appendix\_WOTUS Exhibit).

DP = ACOE Data Sheet Point
