RE: RP002640000100

Moving the building envelope on this site or any other site within the Daydream Ranch Subdivision will not require test holes. Recent test holes dug across the subdivision have shown **NO** evidence of groundwater above 10 feet (120 inches). The location of a residential structure has no bearing on the type or depth of a septic system. There is no need for further soil evaluation on any lot within this subdivision. Minor plat changes such as building envelopes is up to the HOA and the Planning and Zoning Department of Teton County. A change of this sort has no bearing on the State of Idaho subsurface wastewater disposal systems as regulated under IDAPA 58.01.03 legislated rules.

Daydream Ranch Subdivision

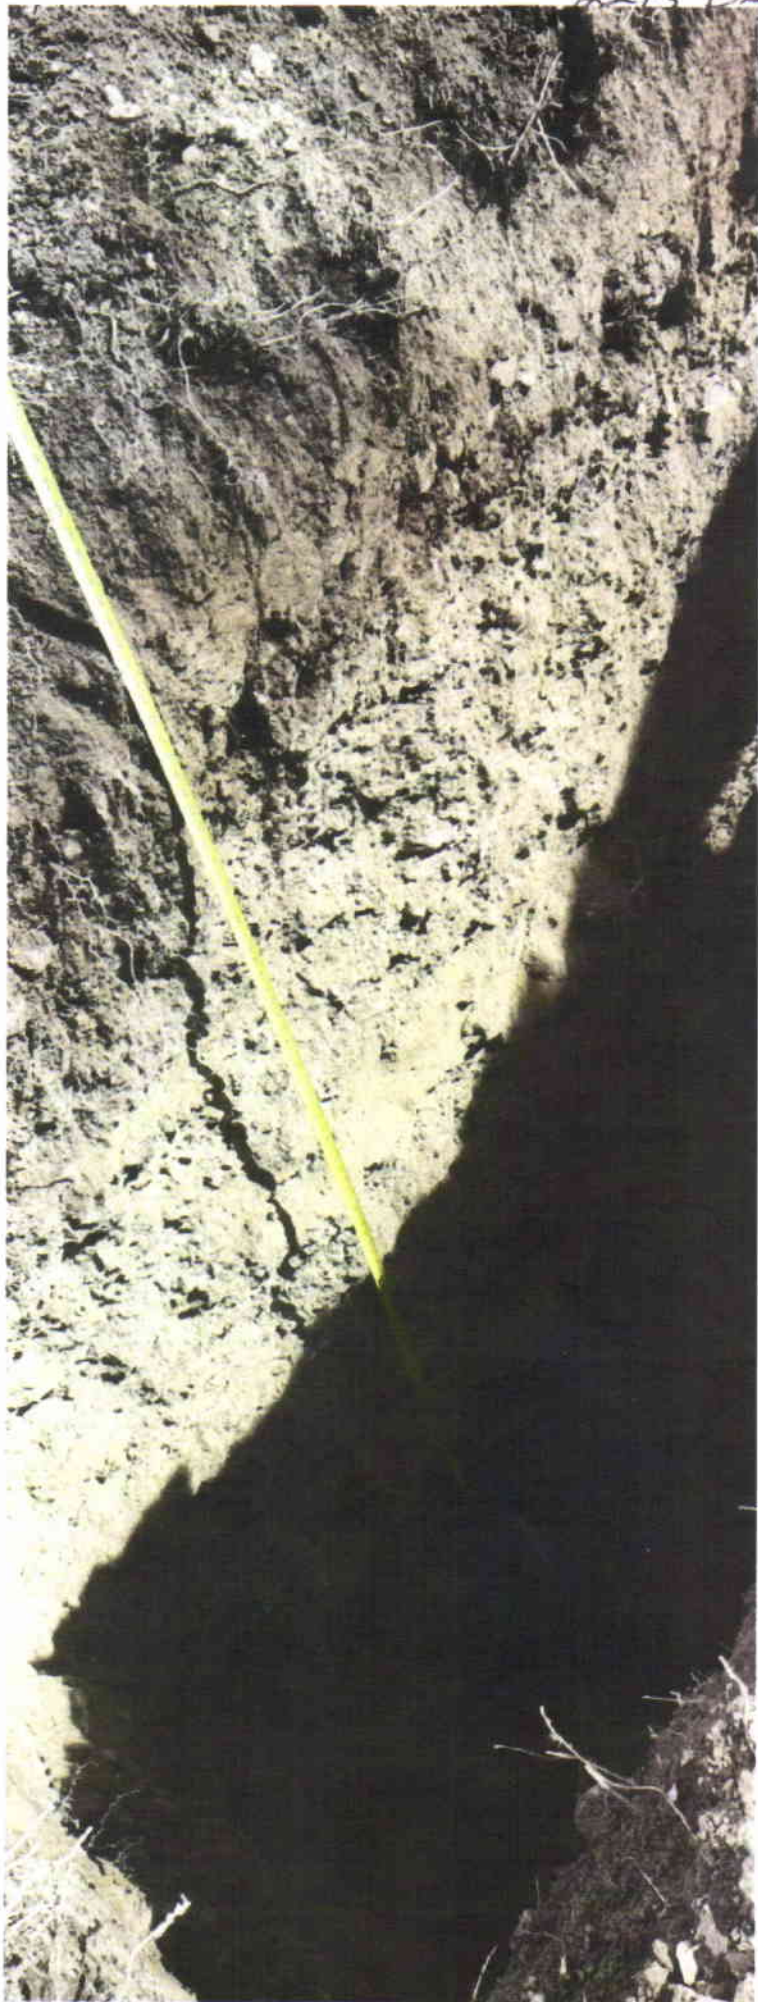
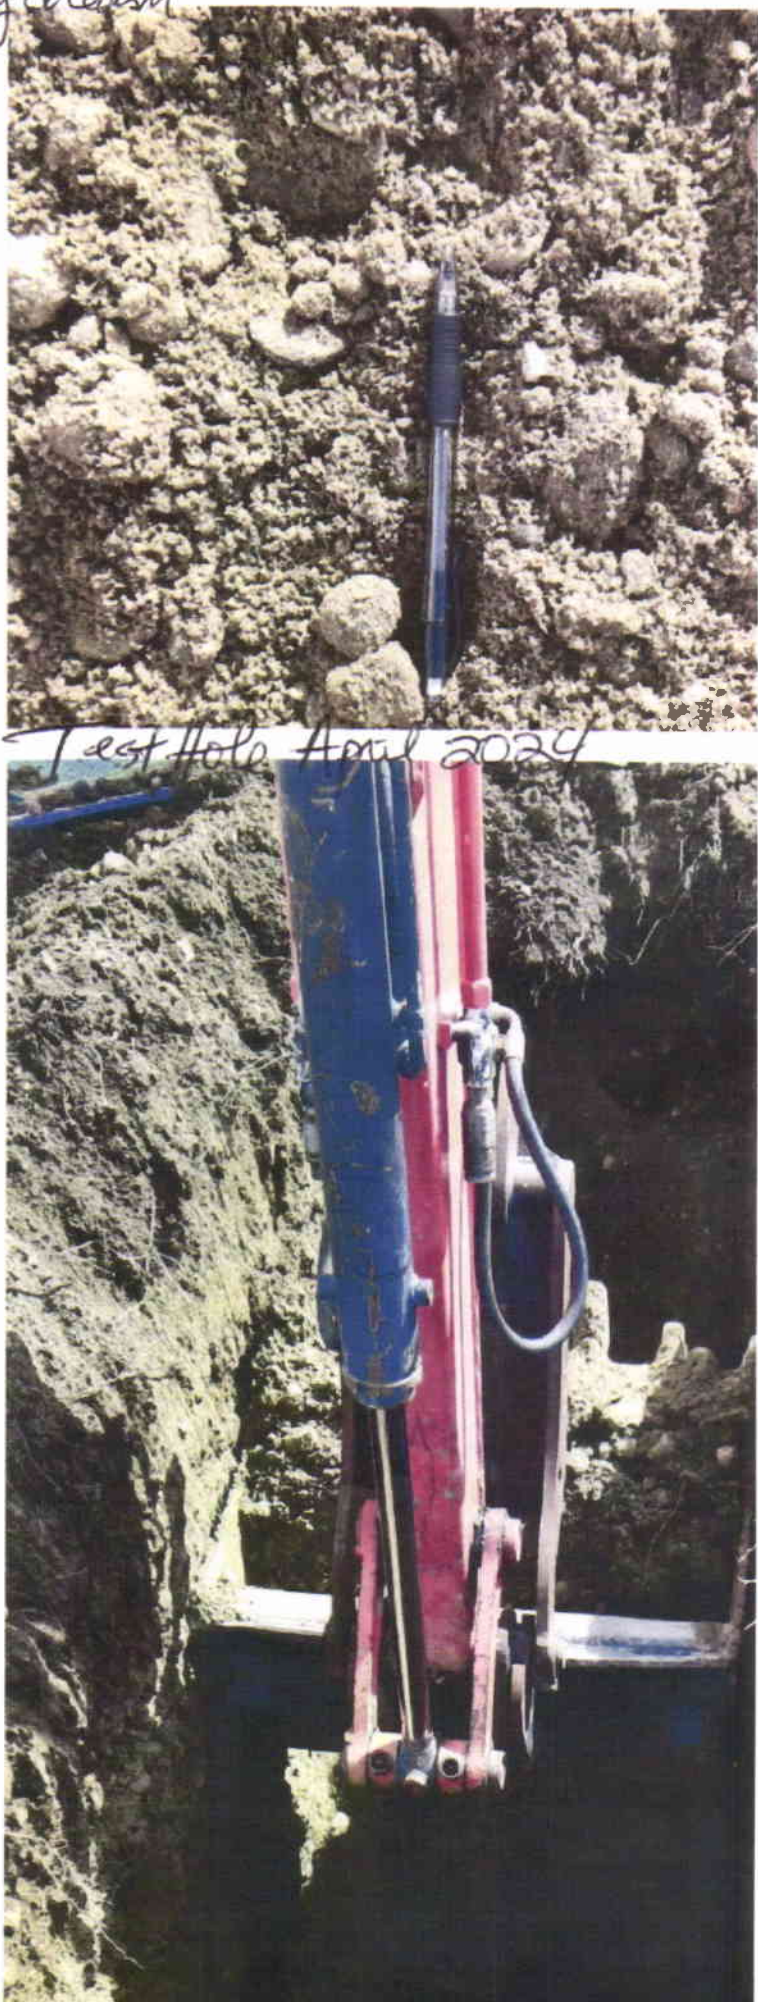
2293 Daydream

0-18 inches of silty loam with minor rock content (Top Soil)

18-114 inches gravely sandy loam. Medium sand. Minor fines. 25% well rounded pebbles up to 3-inch diameter. B1 Soil type.

No bedrock was encountered. There was no evidence of groundwater to depth. No accumulation of water. No mottling of the soil.
