04/23/2024

RE: Daydream Ranch Subdivision

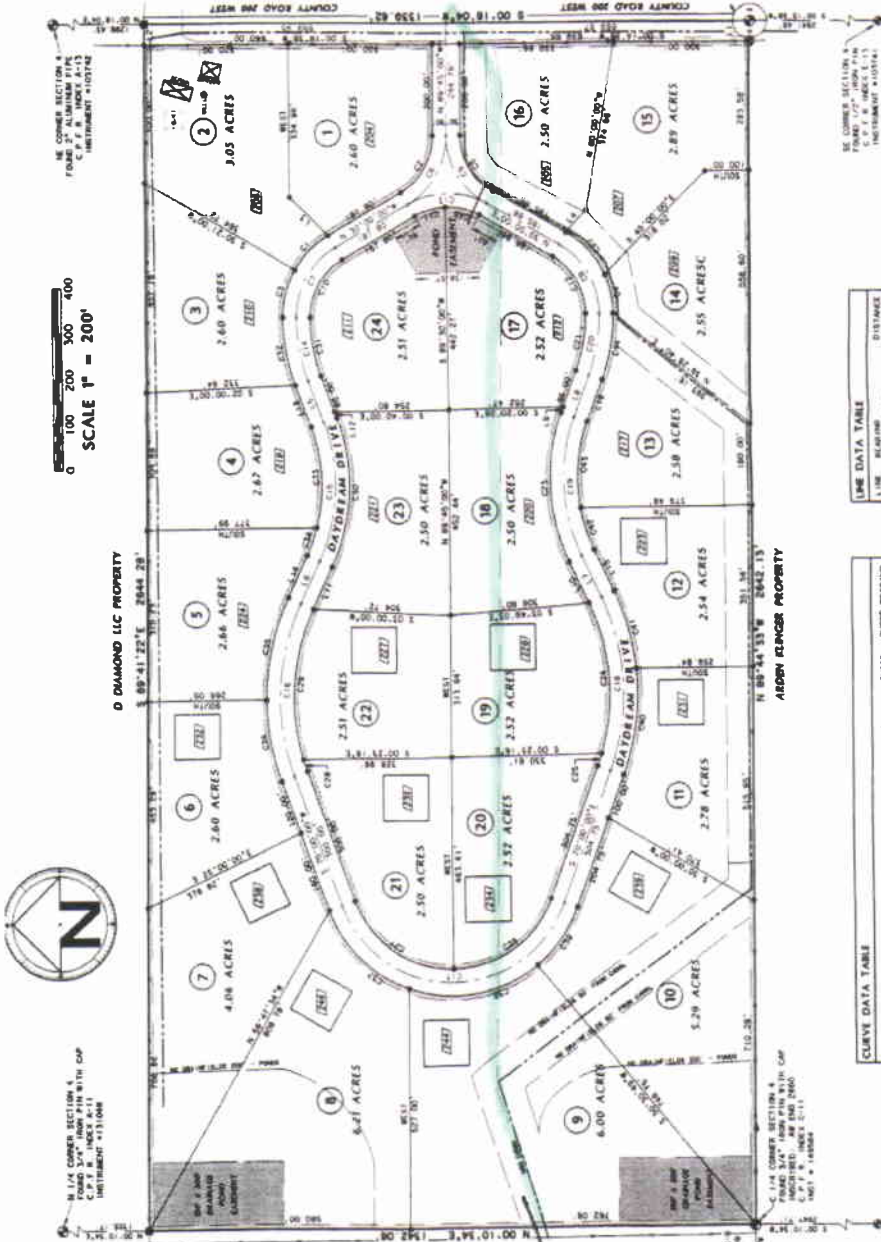
2243 Daydream

Canal separation from D.F. = 50'

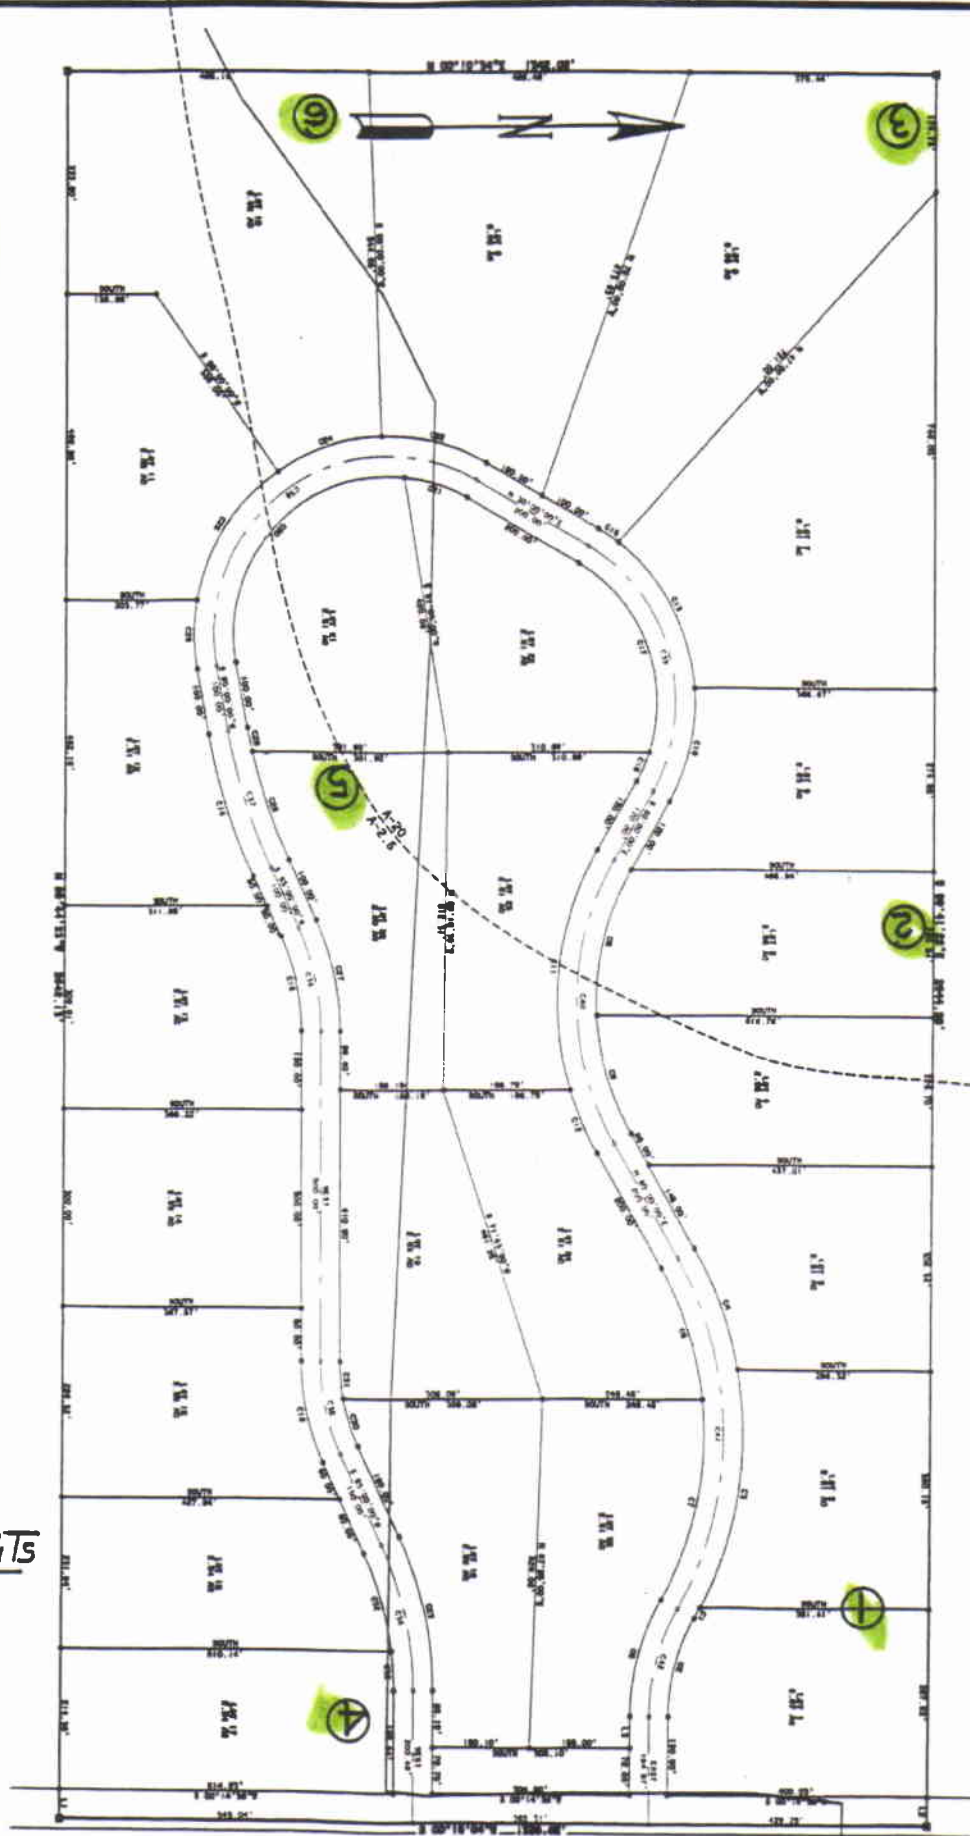
⑤ Soil Test Pits

**Location 1 flooding was caused by water running from ditch along the other side of the west fence.*

*Highest elevation of water below grade -*
