GEOTECHNICAL INVESTIGATION

ROADWAY AND POND CONSTRUCTION PACKSADDLE RANCH 7000 W 4000 N TETON COUNTY, IDAHO

JANUARY 2024 Project No. 23-412-01

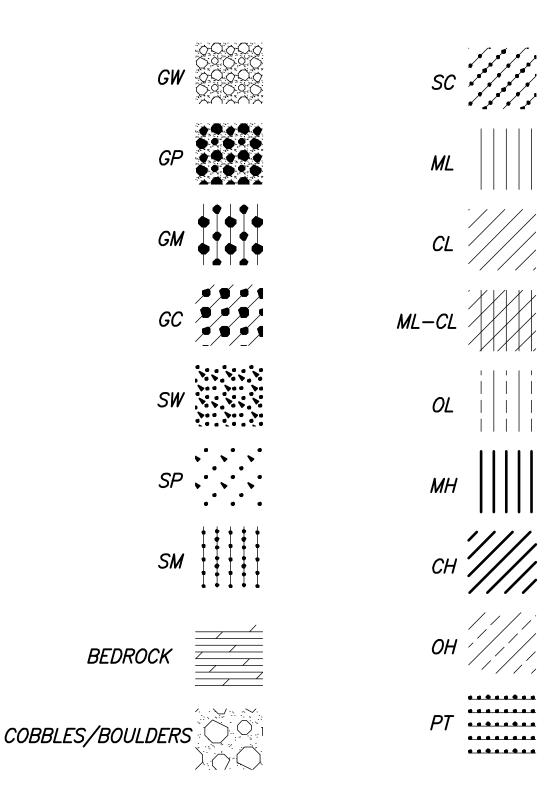
SOIL GRAPHICS

NOTE: ANGLED DEMARCATIONS ON THE LOGS INDICATE APPROXIMATE OR POORLY DEFINED BOUNDARIES BETWEEN SOIL TYPES.

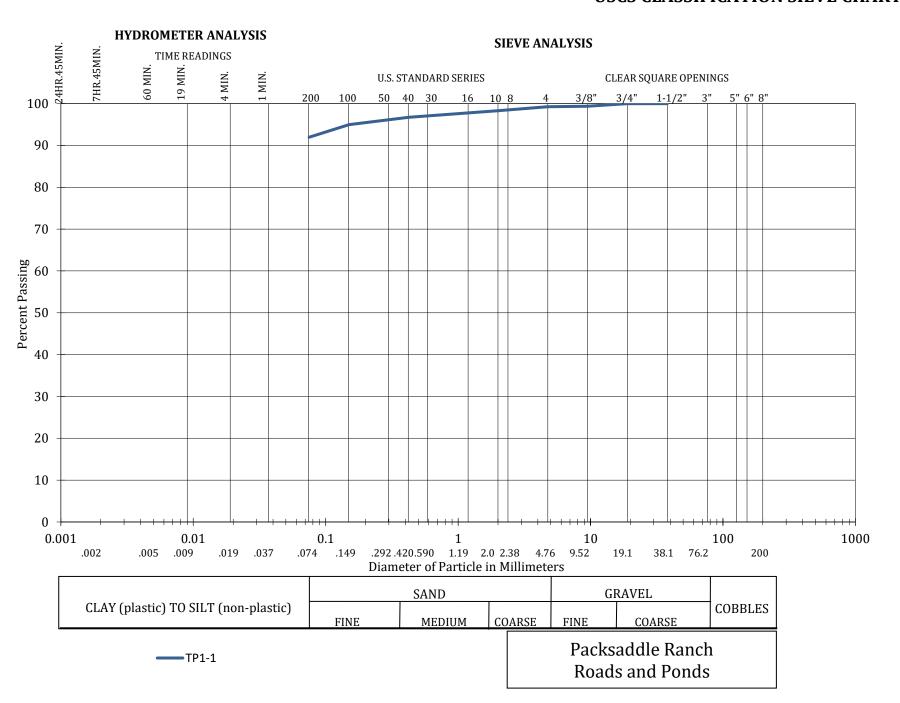
USCS CLASSIFICATION SIEVE CHART

SPLIT GRADATION USCS SOILS CLASSIFICATION
